REPORTS OF
CONSULTING BOARD
ON
LAKE HODGES DAM
SAN DIEGO COUNTY, CALIFORNIA

MEMBERS OF BOARD
B. A. ETCHEVERRY F. C. HERRMANN A. KEMPKEY
HENRY D. DEWELL

1929

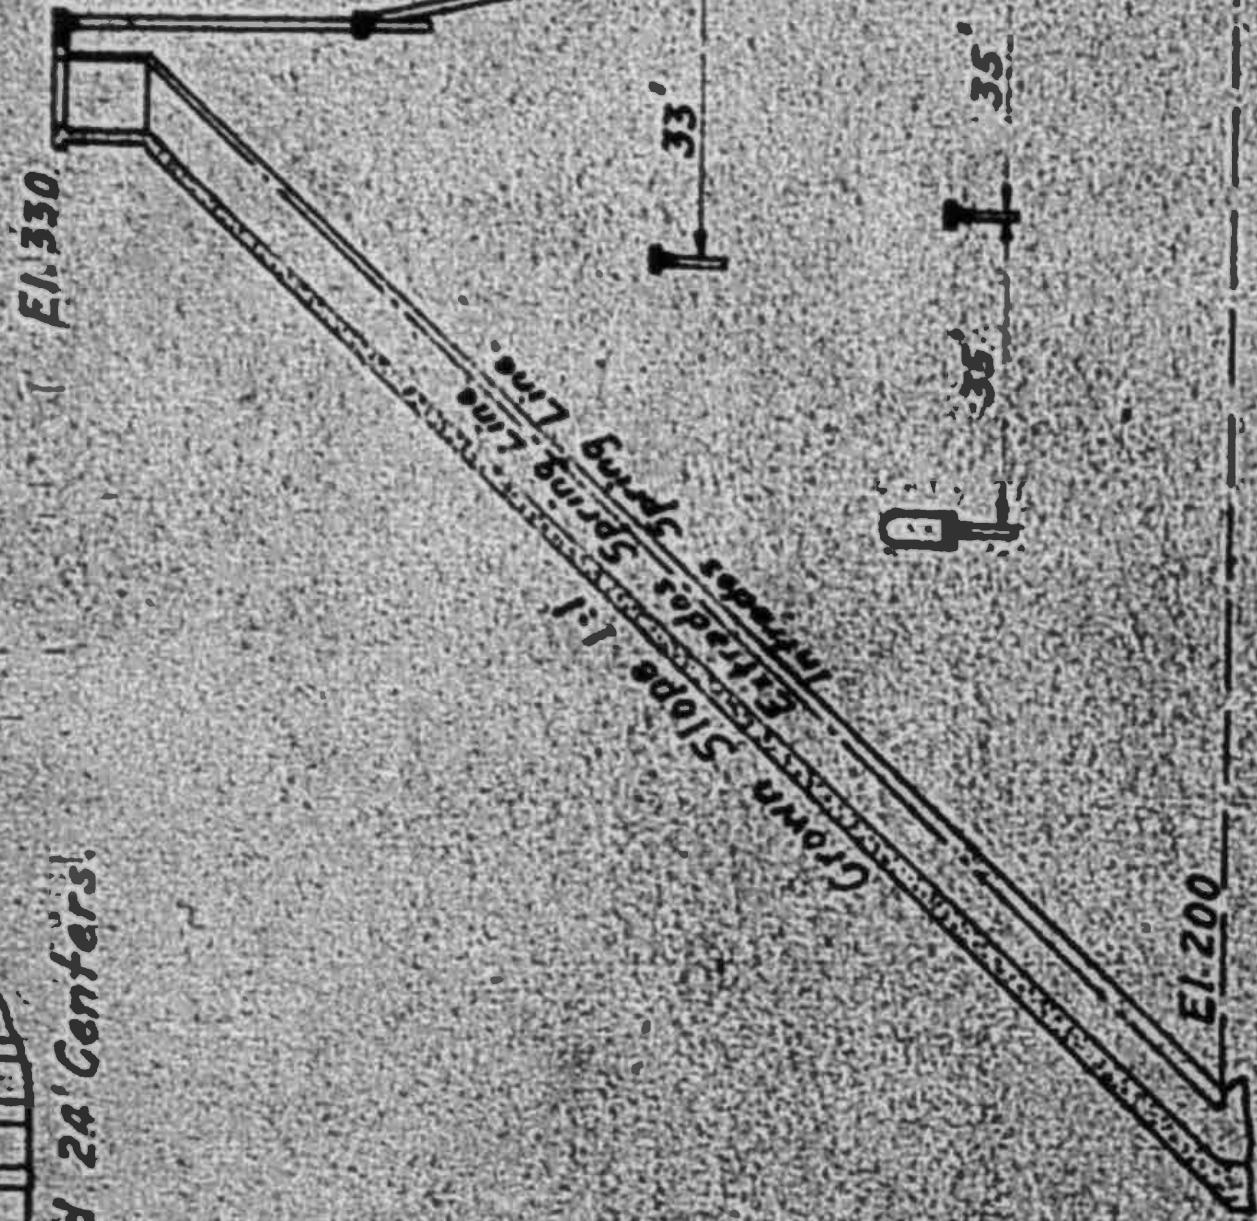
PLATE 2

The cracks have been mapped and are shown on diagrams included in Mr. Brahtz's report. A typical crack is shown on Plate 2 of our report. The cracks generally extend upward from the roof of the gallery archway toward the arch rings in a direction about at right angles to them, and downward from the floor of the gallery foot walk about vertically toward the foundation. The cracks have a maximum width at the gallery. They gradually decrease in width in either direction from the gallery, and end before reaching the arch rings at the upper end and the foundation at the lower end, with the exception of one crack the upper end of which extends for a short distance into the arch ring.

Sketch showing position of crack in Buttress No 6
The position of crack is typical of that in all
butresses though this is longer than cracks
in other buttresses.
Note:- Crack does not enter either the arch
ring or the base of Buttress.

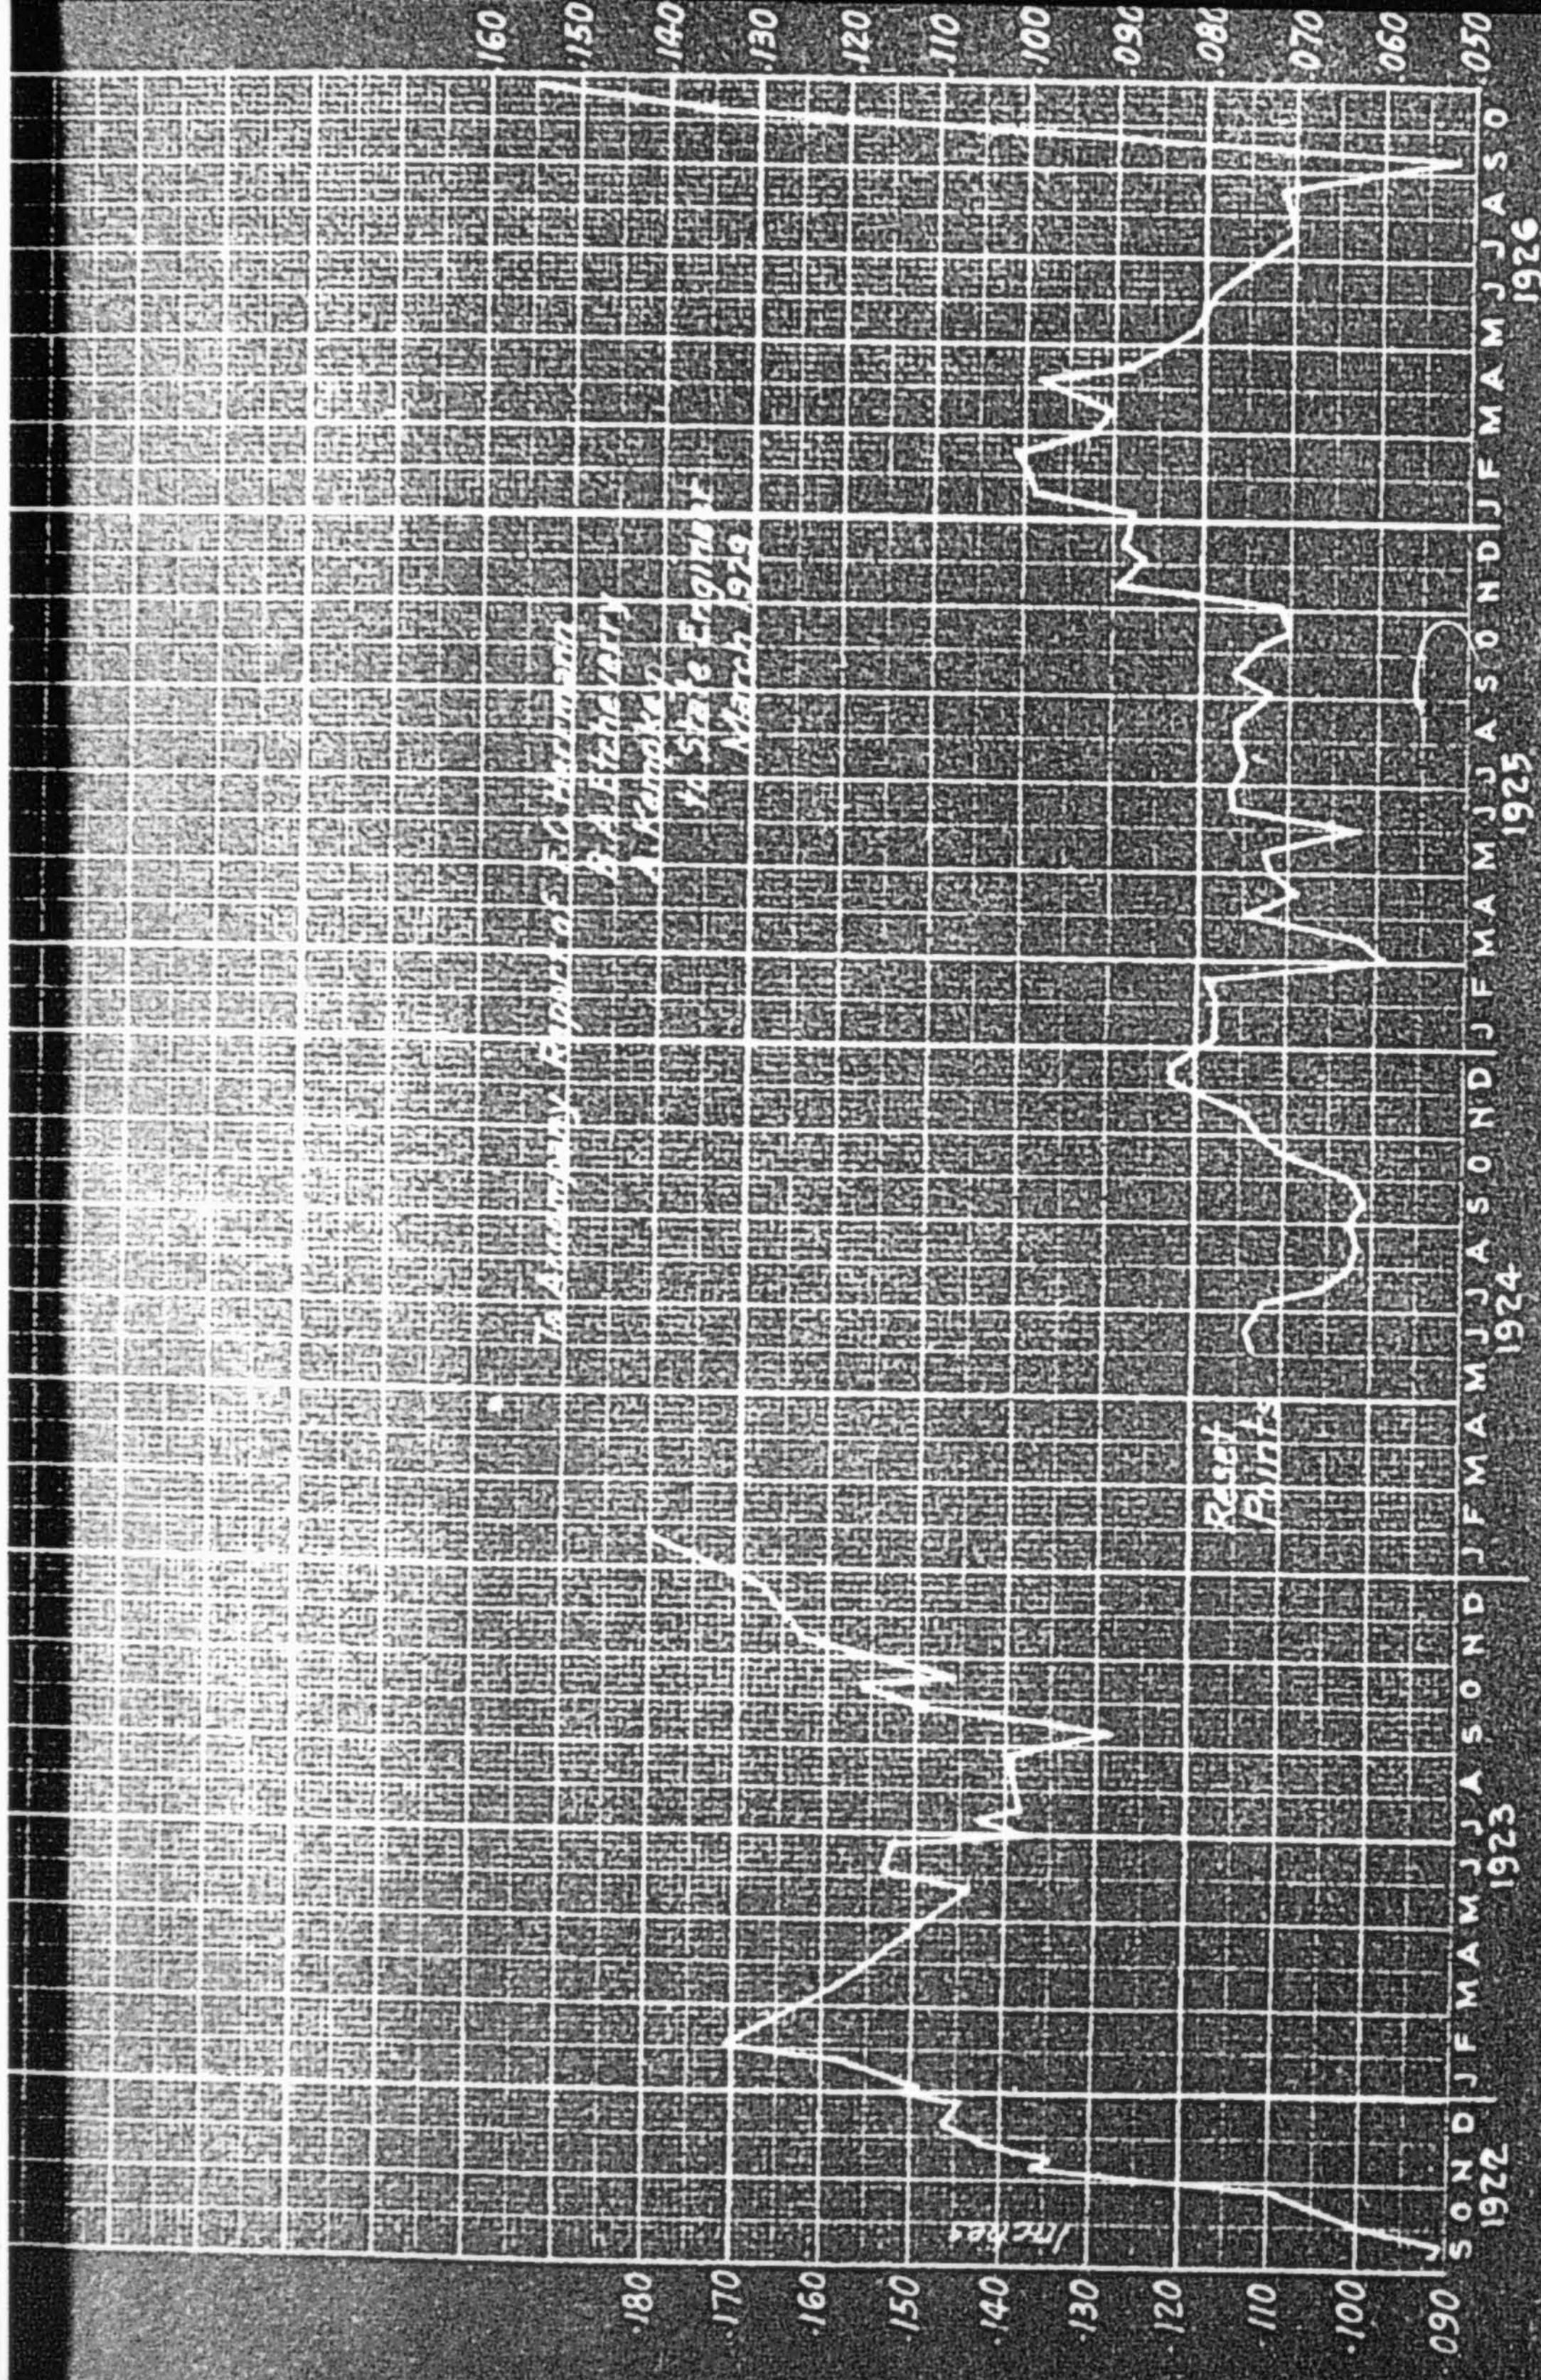
Lake Hodges Micrometer Readings
Buttress No. 18 South Side PLATE 6

We have plotted on separate graphs the micrometer measurements of the changes in the horizontal and vertical components of the width of the cracks, (Plates 3 to 7), and have studied the factors which might have a tendency to effect the changes, including the records of temperatures taken in the buttresses and the variations in water level in the reservoir.

during the winter and their minimum widths during the late summer. There is a gradual small increase in the width of the cracks from one season as compared to that of the preceding season. The average annual permanent increase in the vertical and horizontal components of the width of cracks is each approximately one-one-hundredth of an inch.

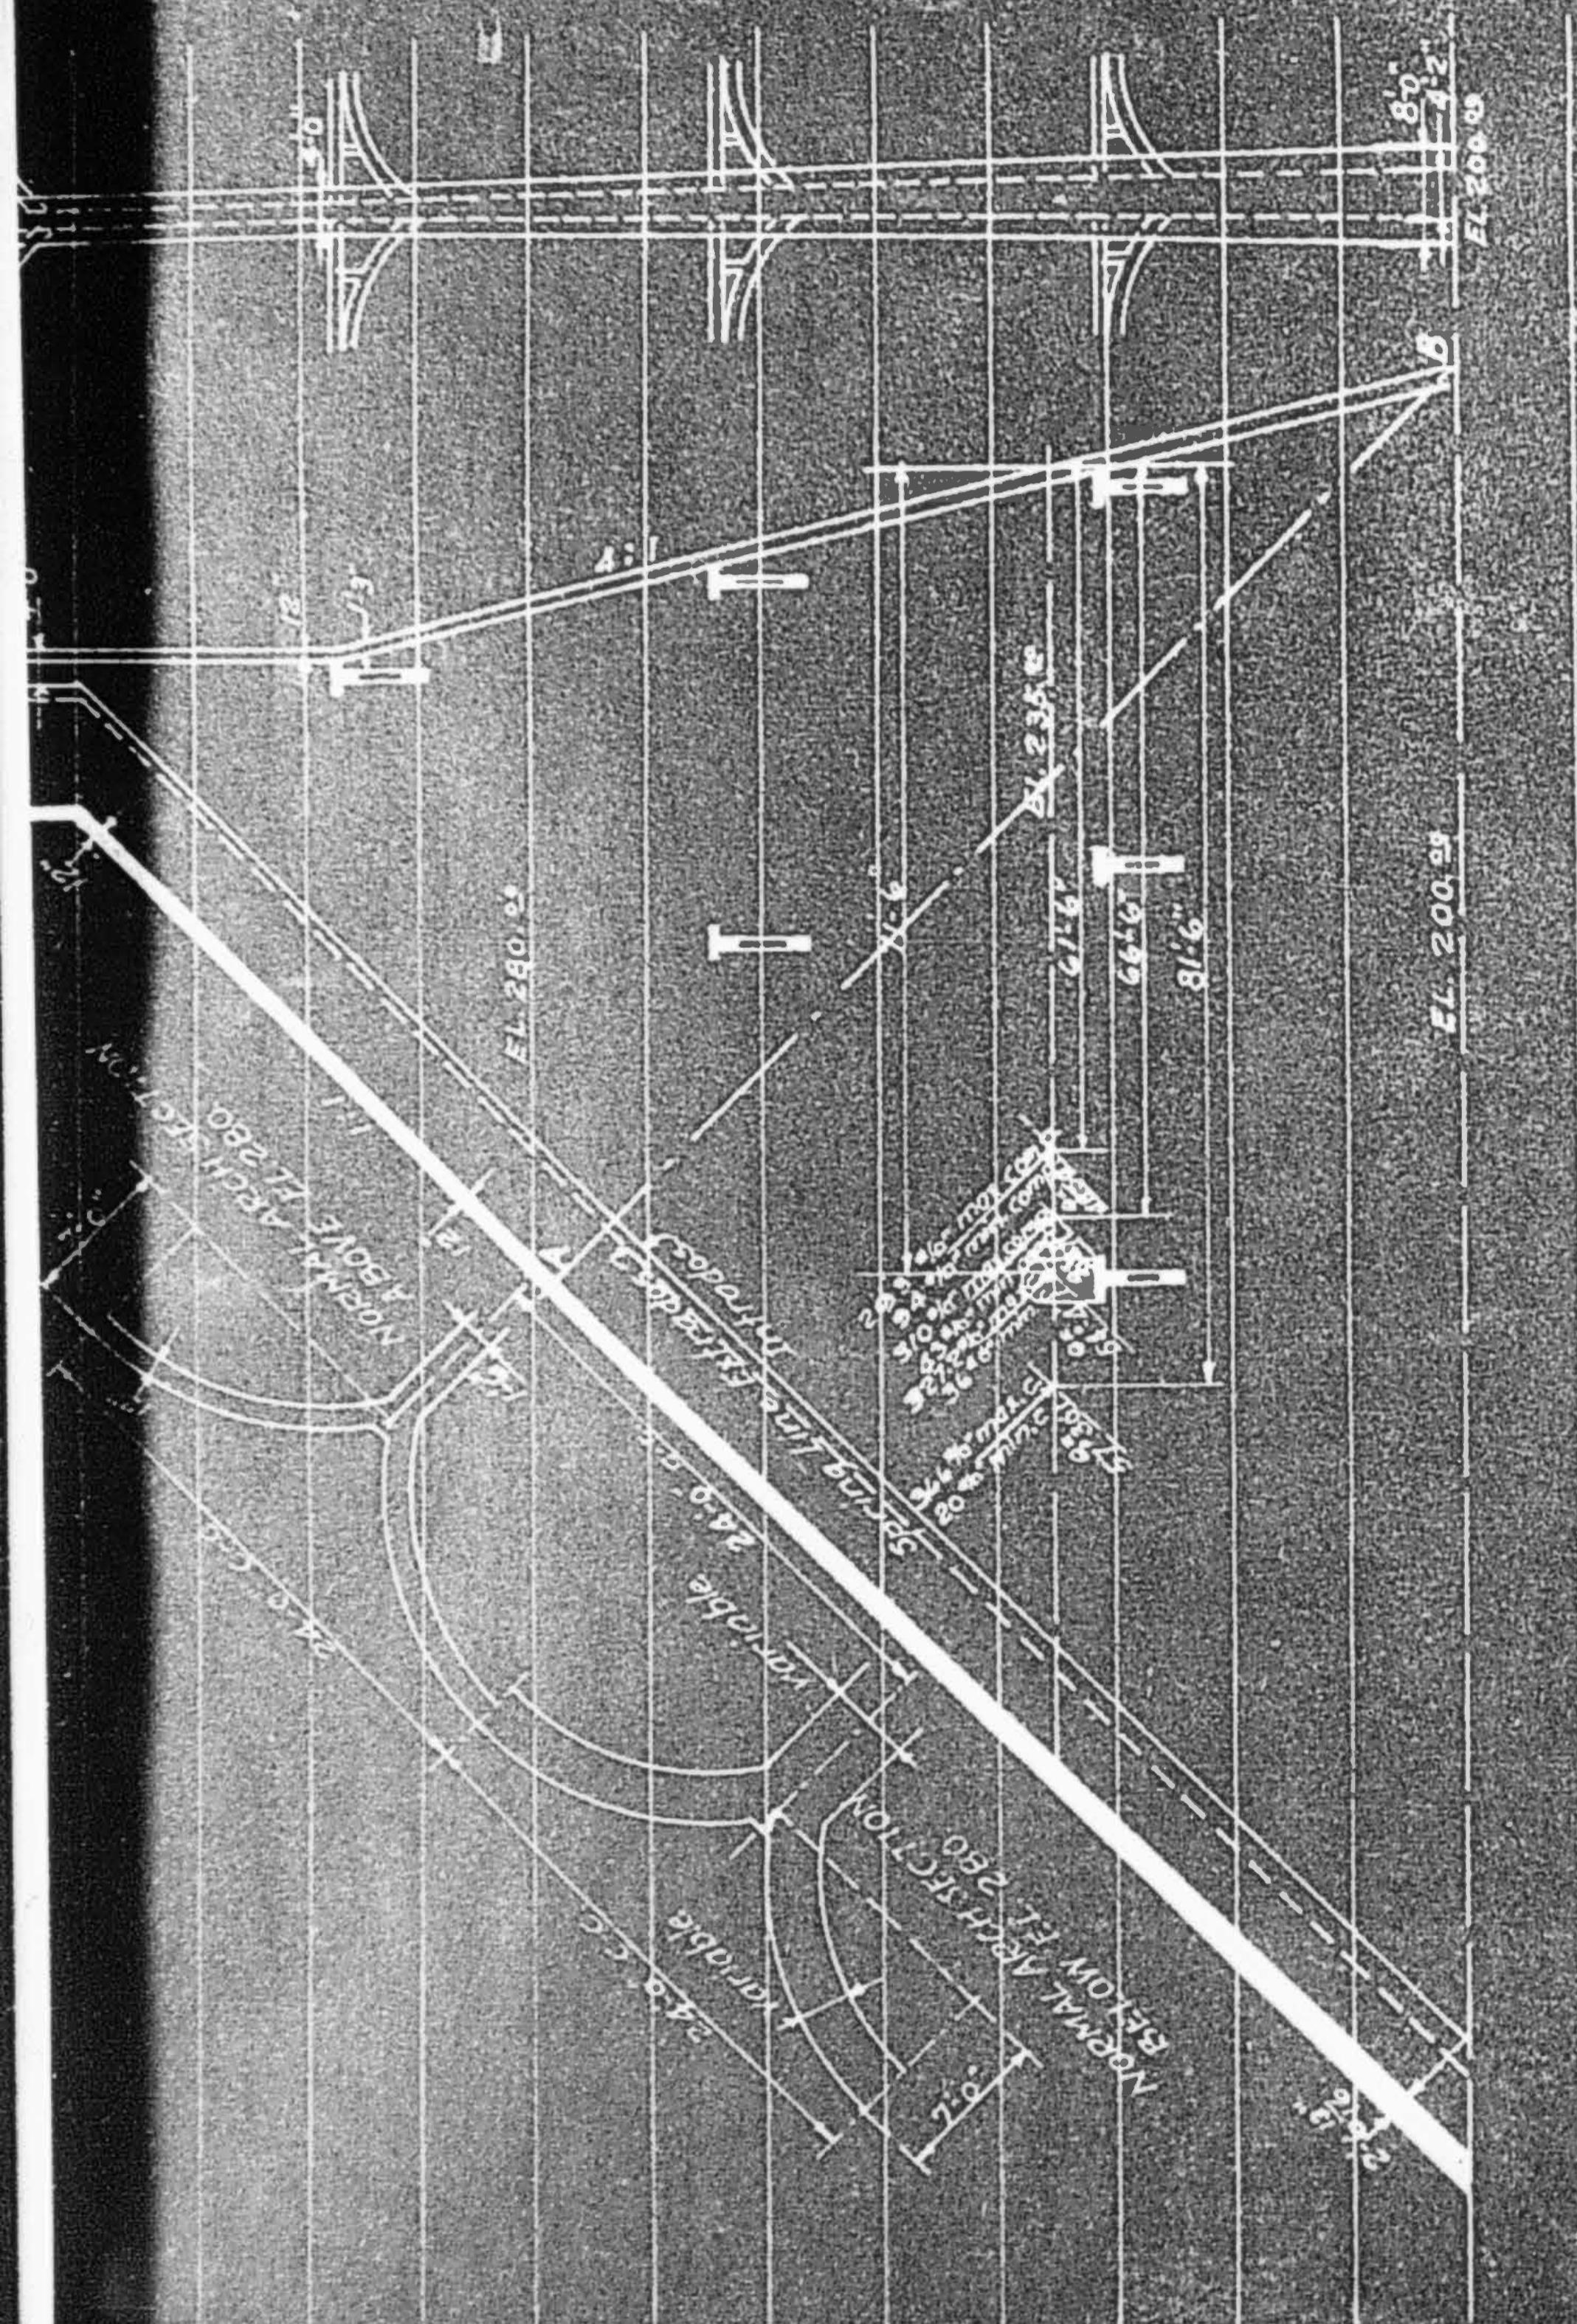
DIAGRAM OF BUTTRESS, MIKE HOODA'S DAM
SAN DIEGO COUNTY, CALIFORNIA
TO OCCIDENTAL COMPANY, DEPT. OF
HENRY D. DAVELL, Consulting Engineer
Dated March 12, 1929

These four points, and the stresses found, are shown on Figure 1. The four points are at distances 61' - 6", 66'-6", 71'-6" and 81'-6", respectively, from the back face of the dam. The point which is 71'-6" from the back face is at the center of the gallery opening. Table V, below gives the results of these computations.

These results indicate that, for the uncracked buttress, there is no tension across an inclined plane following the present crack. Certain points, which may have some significance, are to be noted from the figures of Table V.

(1) The plane on which the minimum compressive stress acts has the same direction as the present crack.

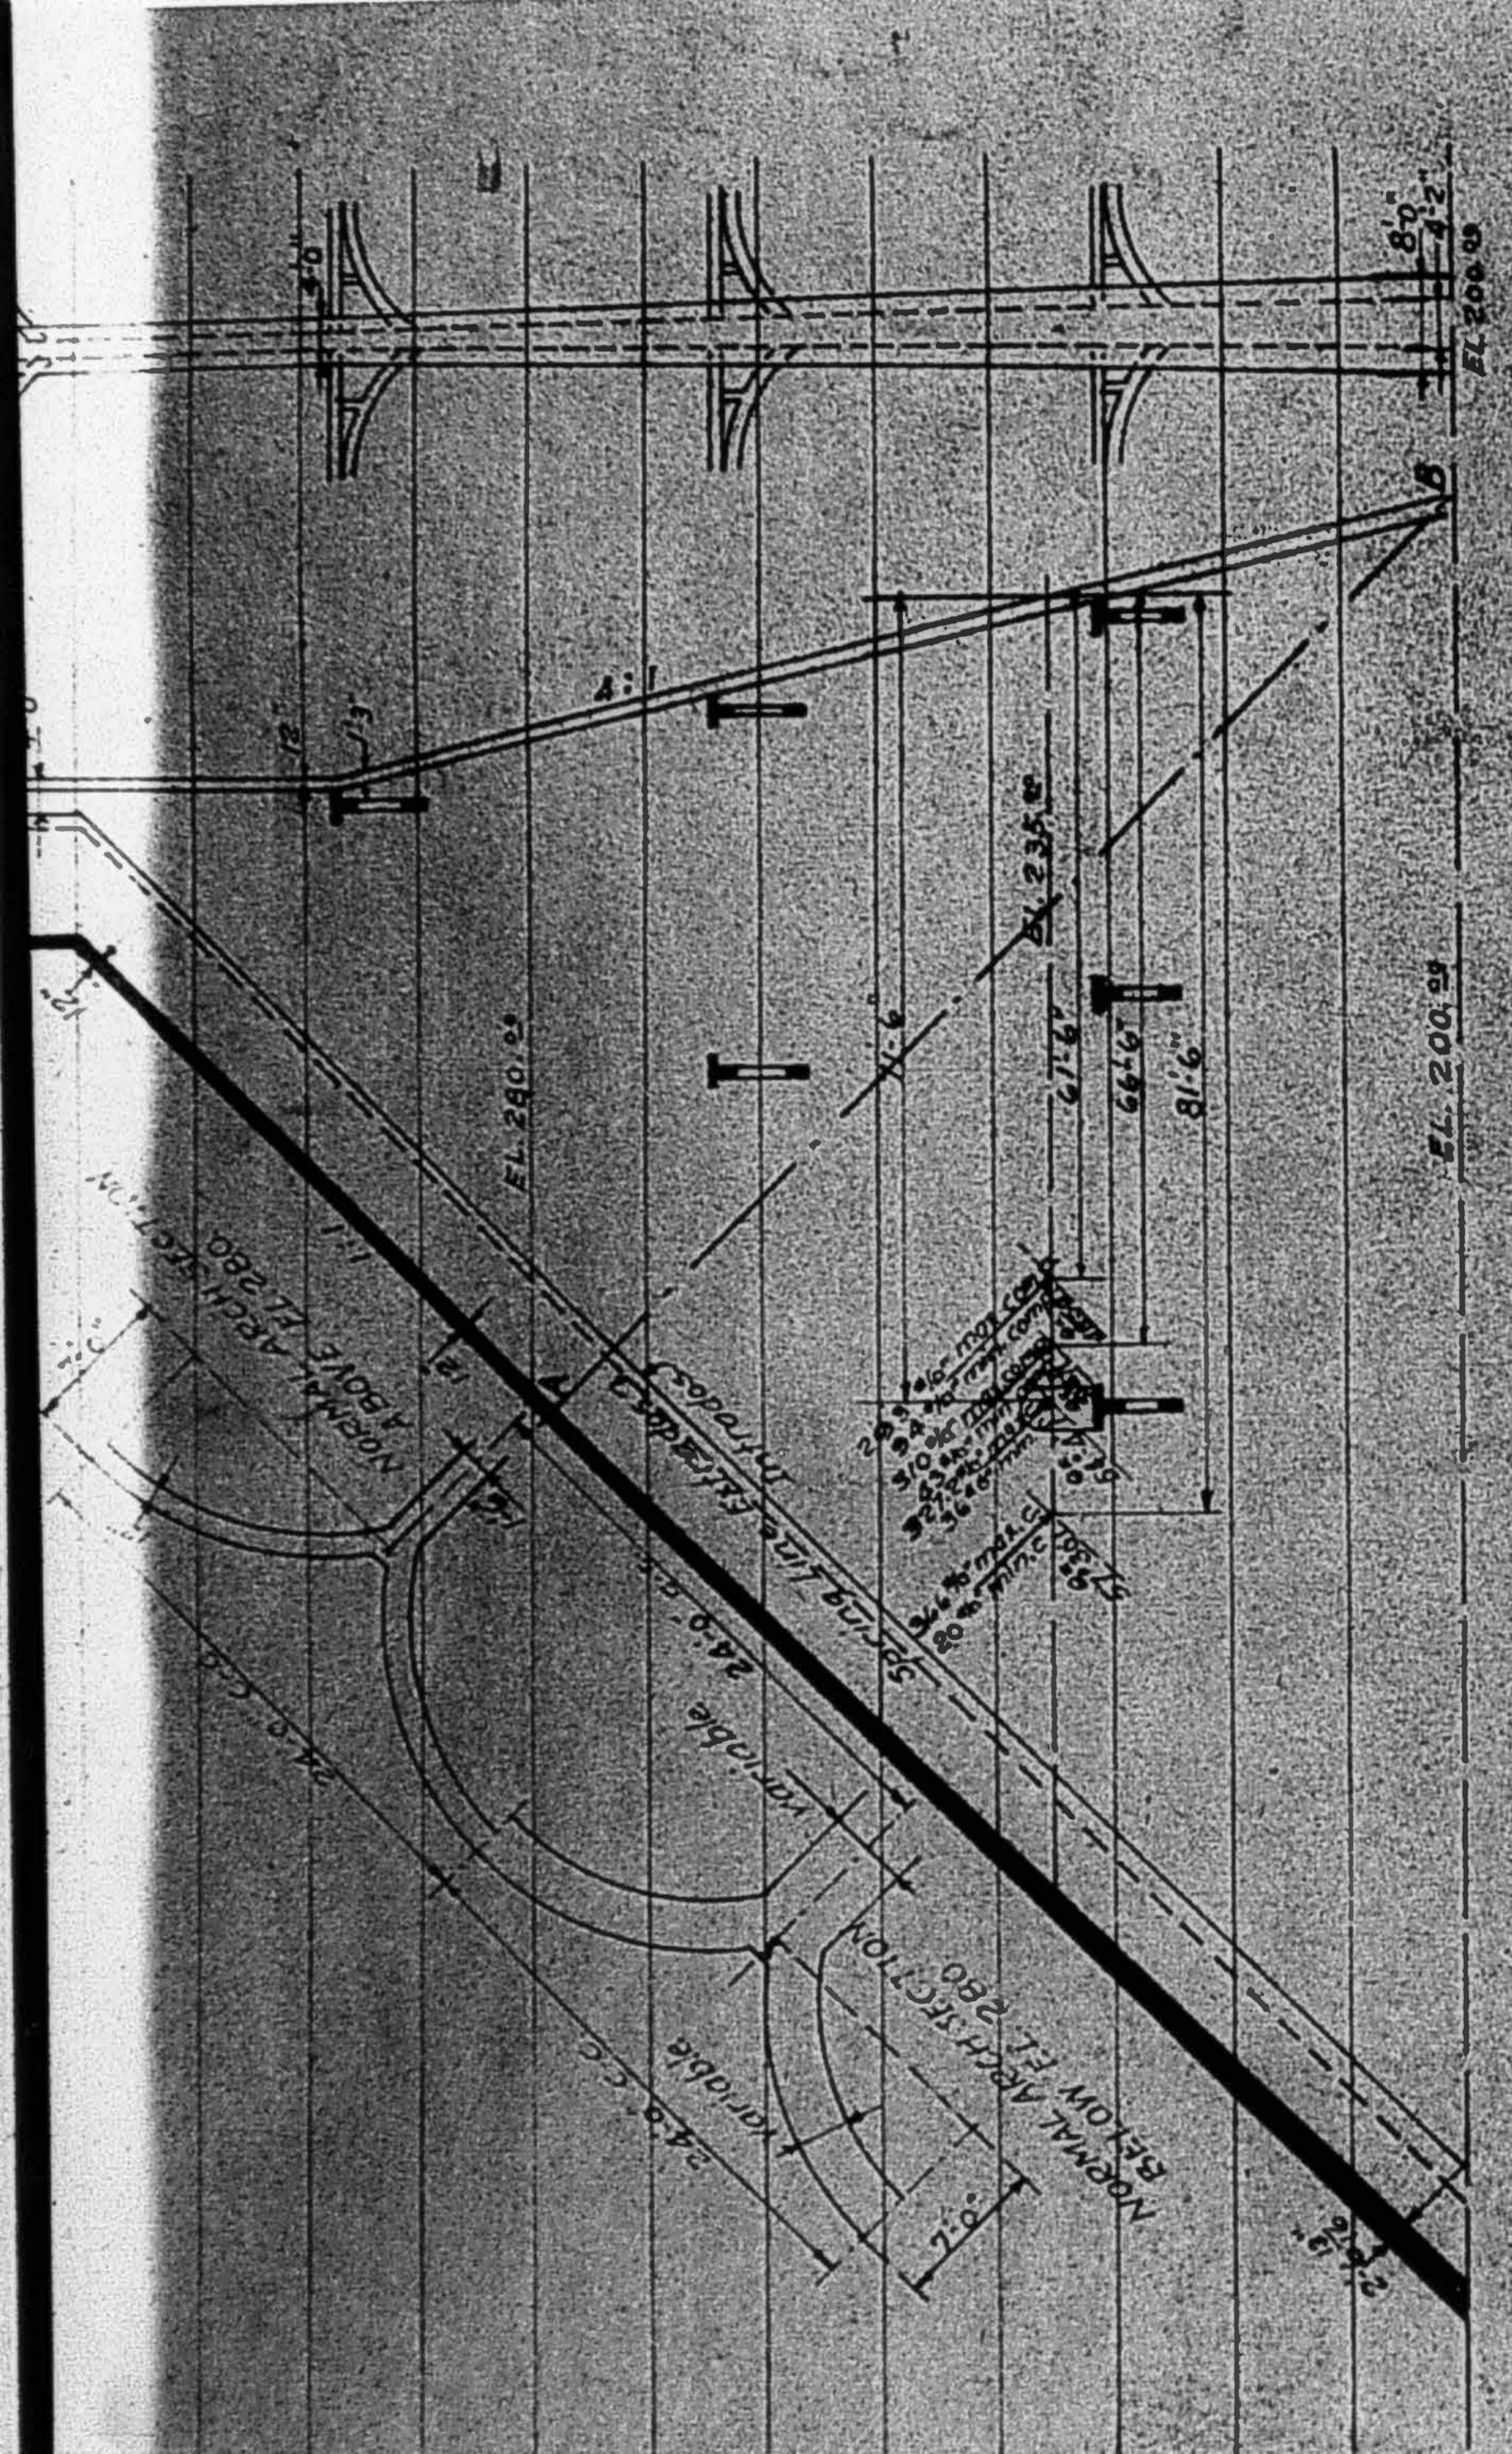
COMPUTED SOIL PRESSURES
FOR DAM WHEN ASSUMED TO
BE DIVIDED BY CRACK INTO
TWO PORTIONS.

This analysis, together with the studies of Mr. Dewell, show that while the distribution of the foundation pressures would be changed, the maximum pressures resulting therefrom would not be excessive.

Mr. Brahtz has made a detailed study of the effect of the cracks, assuming that they extend completely through the height of the buttress, i. e., from arch to foundation. Without giving details of his computations, he finds that the dam would be safe with the buttresses so cracked, except for the "long-column" action discussed previously.
