The George H. Scripps Memorial Marine Biological Laboratory
of the Scripps Institution of Oceanography
University of California, San Diego

Historic Structure Report to the California Office of Historic Preservation

SIO Reference 79-26

October 1979

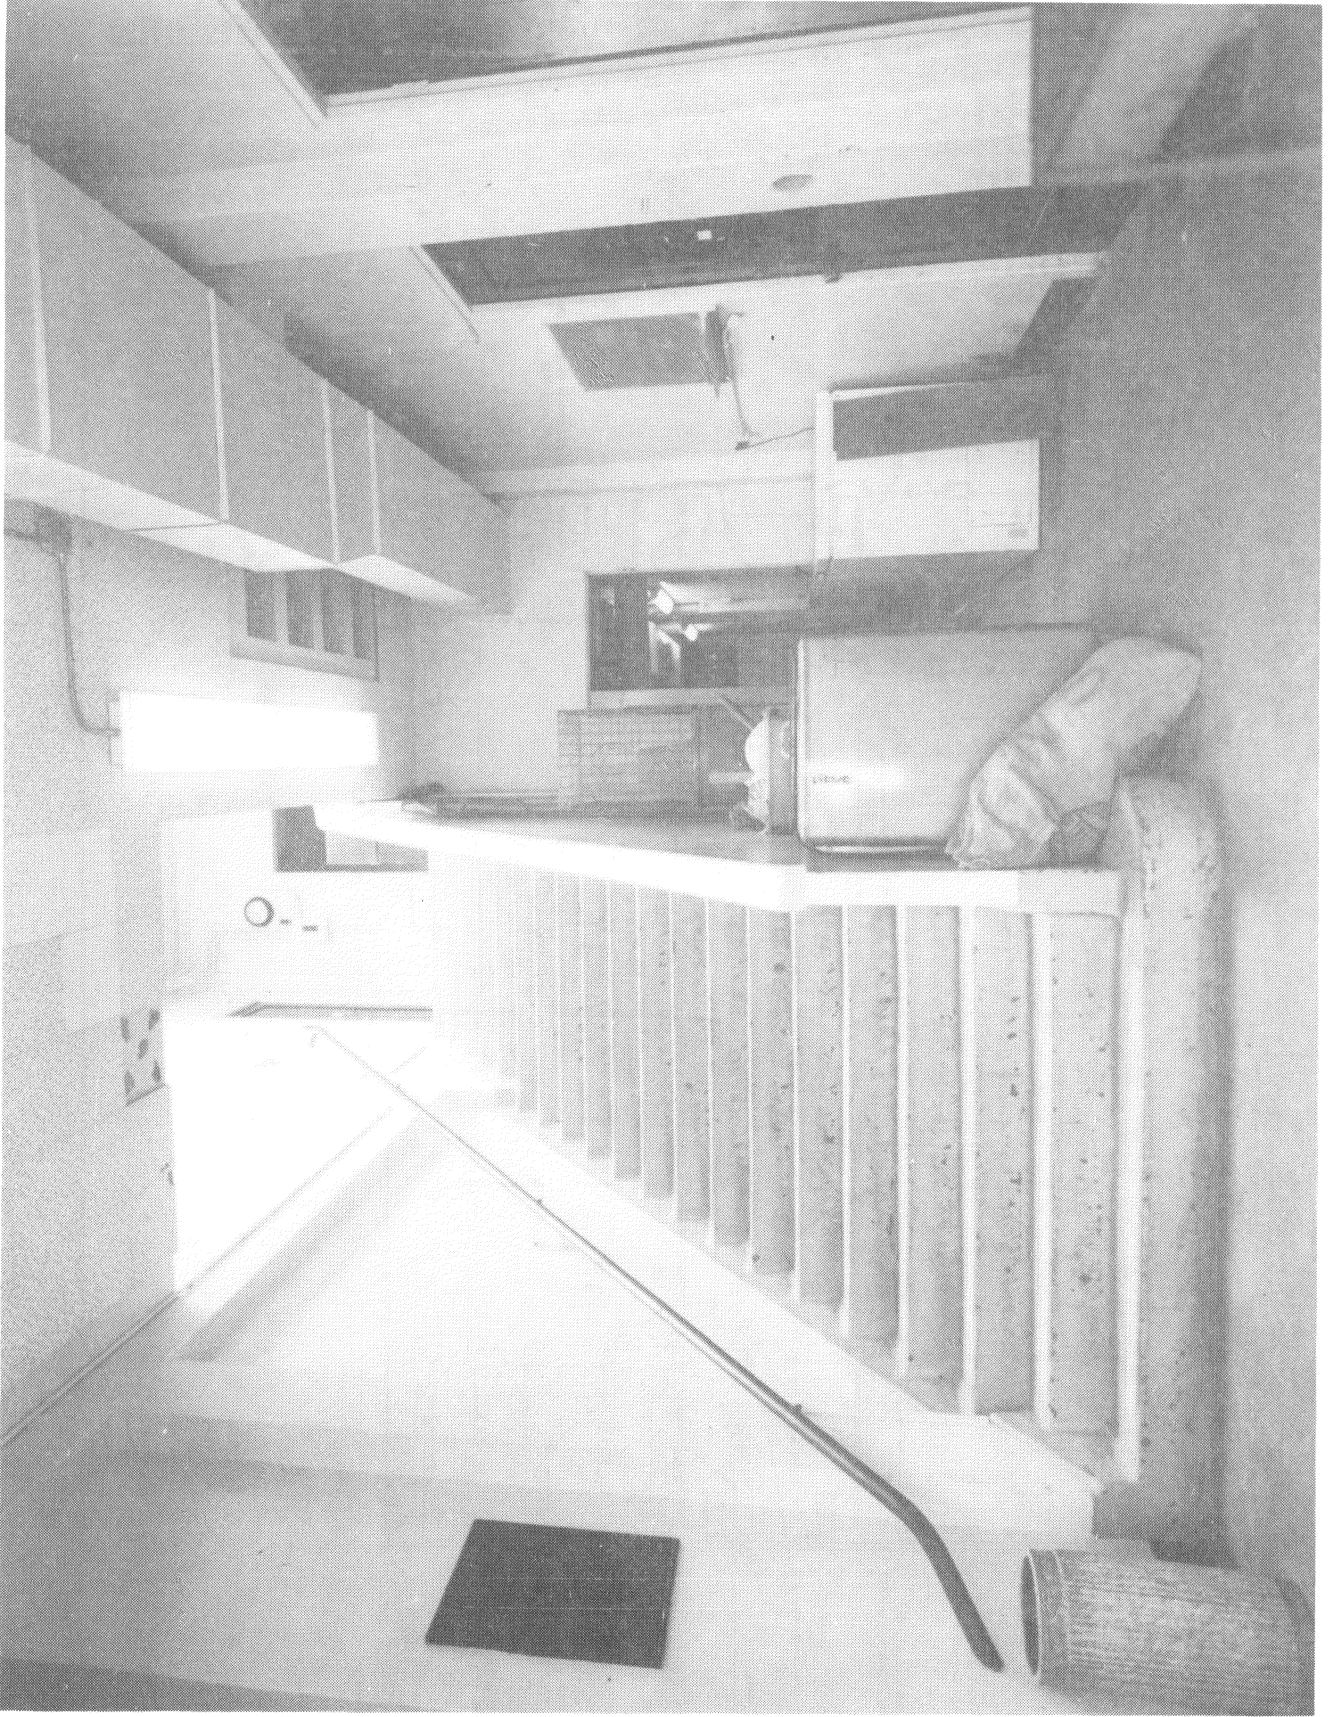
Figure 9. East corridor of Scripps Laboratory just before the scientific staff moved out in June, 1977.

The degree of deterioration of the reinforcing rod and concrete is not fully known. In some locations, spalling of concrete is obvious, and reinforcing rods are rusted to powder; in other areas tested by coring or chipping the reinforcement is uncorroded. In general, the areas of most obvious damage are at the foot of columns and the base of some interior walls, where seawater overflow from aquaria has entered the concrete. It was suggested by John Kariotis (personal communication) that this damage may have been caused by segregation of the concrete, with voids formed between aggregate at the bottom of the forms, which permitted entrance of the seawater. The most obvious area of spalling and corrosion is in the south side of the large column that forms the frame of the west exterior door. This apparently continues down into the adjacent wall that forms the west wall of the old aquarium room (room 13). Another obvious area of spalling is on the east exterior wall, at the base of the column nearest the seawater-intake pipe (by room 21). Additional areas of spalling and corrosion can be noted at the base of the column at the junction of rooms 20 and 21 with the corridor, and at the lintel above the north windows of rooms 204 and 205. Serious deterioration of the plaster is apparent in the walls of rooms 13 and 18, both of which were used for aquaria for many years.

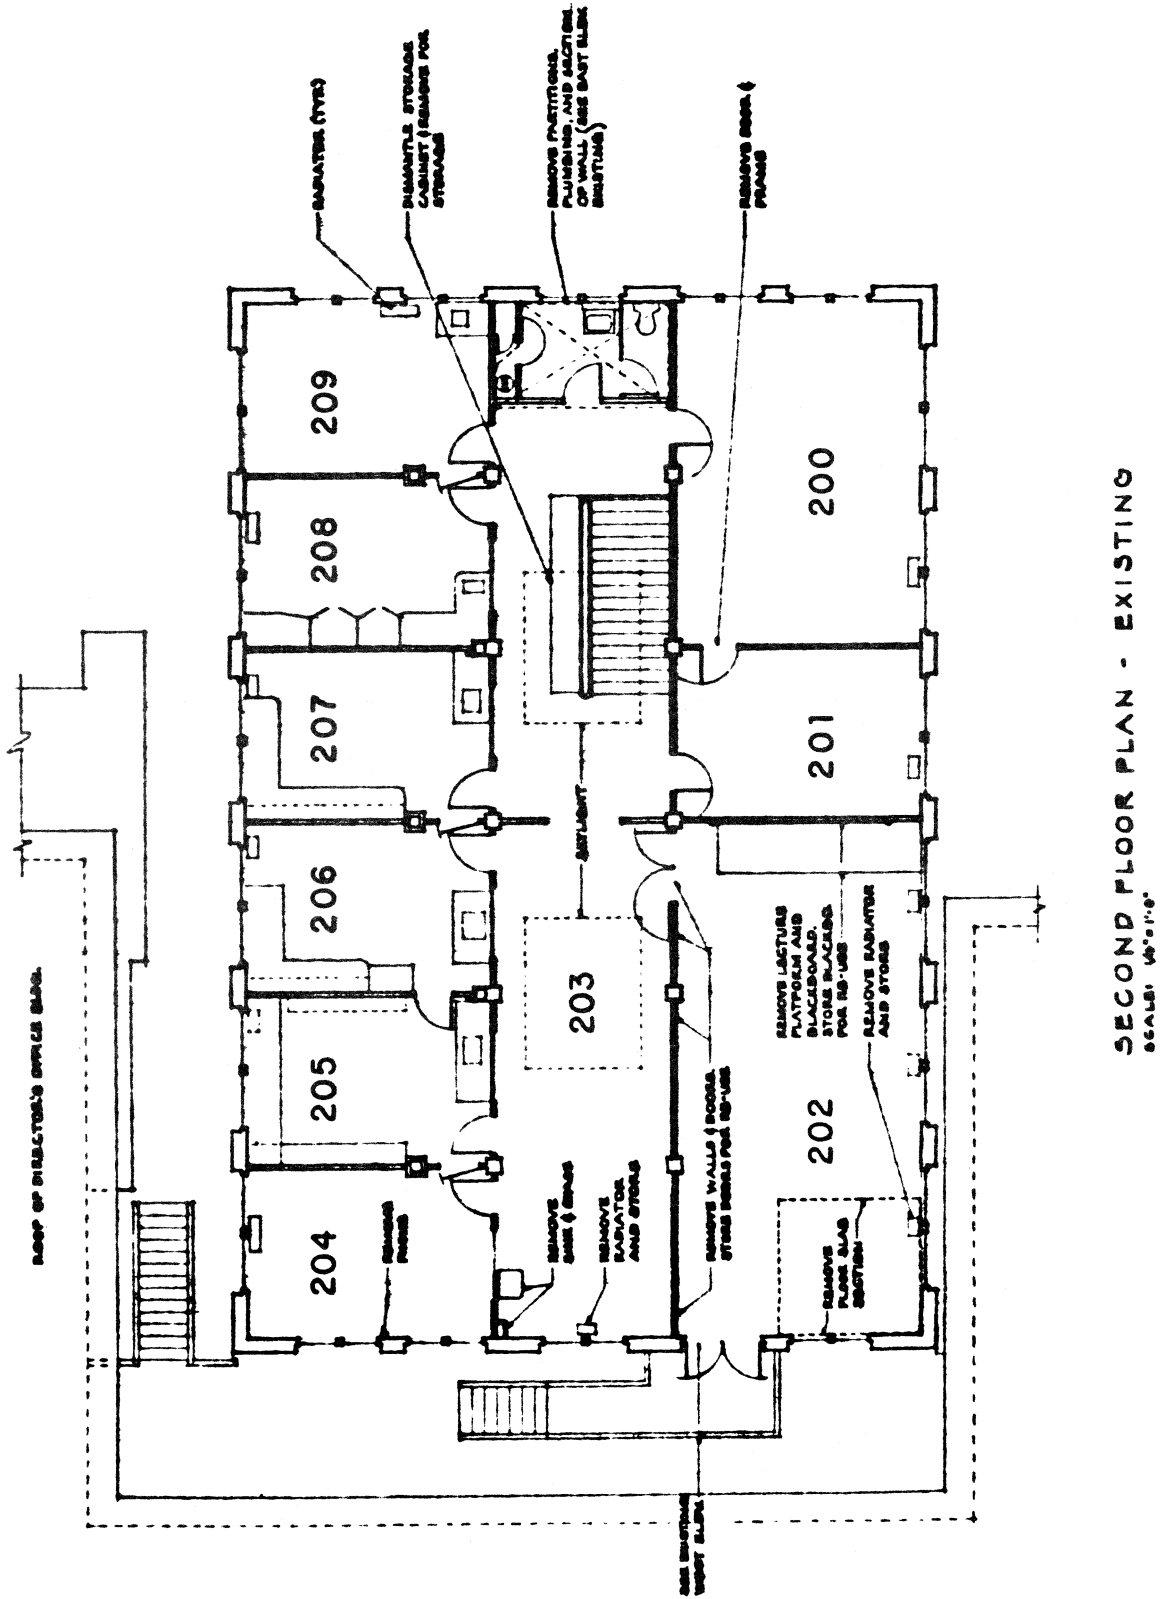
Figure 11. Second floor plan in May, 1979, with current room numbers.

The parapet is badly cracked and vent pipes within it are corroded. Roof leaks in recent years have been serious and have caused damage to ceiling plaster, wall plaster, and floor tiles in rooms 200, 206, and 208.

Much of the existing deterioration of the building can be traced to faulty roofing and roof drainage. The existing roofing will be removed and replaced with a 4 ply built-up roof on 1½" urethane foam insulation. All downspouts will also be reworked and replaced. The existing somewhat deteriorated concrete parapet will be covered with a metal parapet cap and existing plumbing vents will be removed and plugged to provide a weather tight condition.

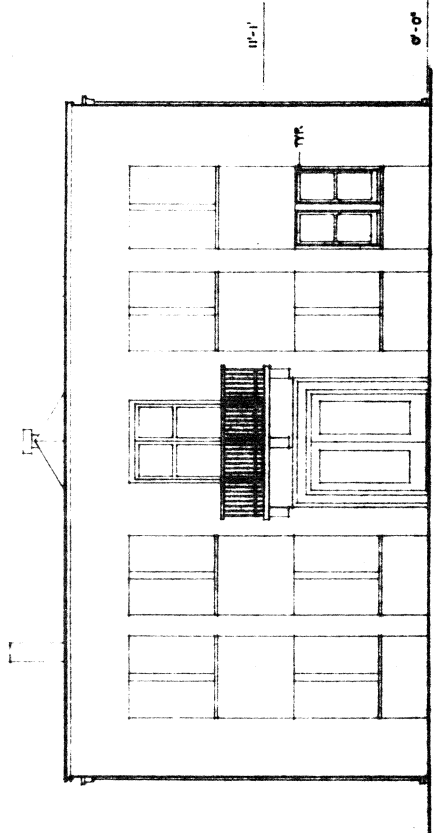
NEW EAST ELEVATION 1/8"=1'-0"

EXTERIOR NOTES
 REMOVE EXISTING COATING
 CHEMICALLY TREAT SURFACE
 & CRACKS TO ARREST
 DEGRADATION OF CONCRETE
 APPLY NEW COVER COAT

DID ALTERNATE 'A'
 REPLACES ALL WOOD WINDOWS W/
 STEEL 'AWNING' TYPE WINDOWS
