REPORTS OF
CONSULTING BOARD
ON
LAKE HODGES DAM
SAN DIEGO COUNTY, CALIFORNIA

MEMBERS OF BOARD
B. A. ETCHEVERRY F. C. HERRMANN A. KEMPKEY
HENRY D. DEWELL

1929

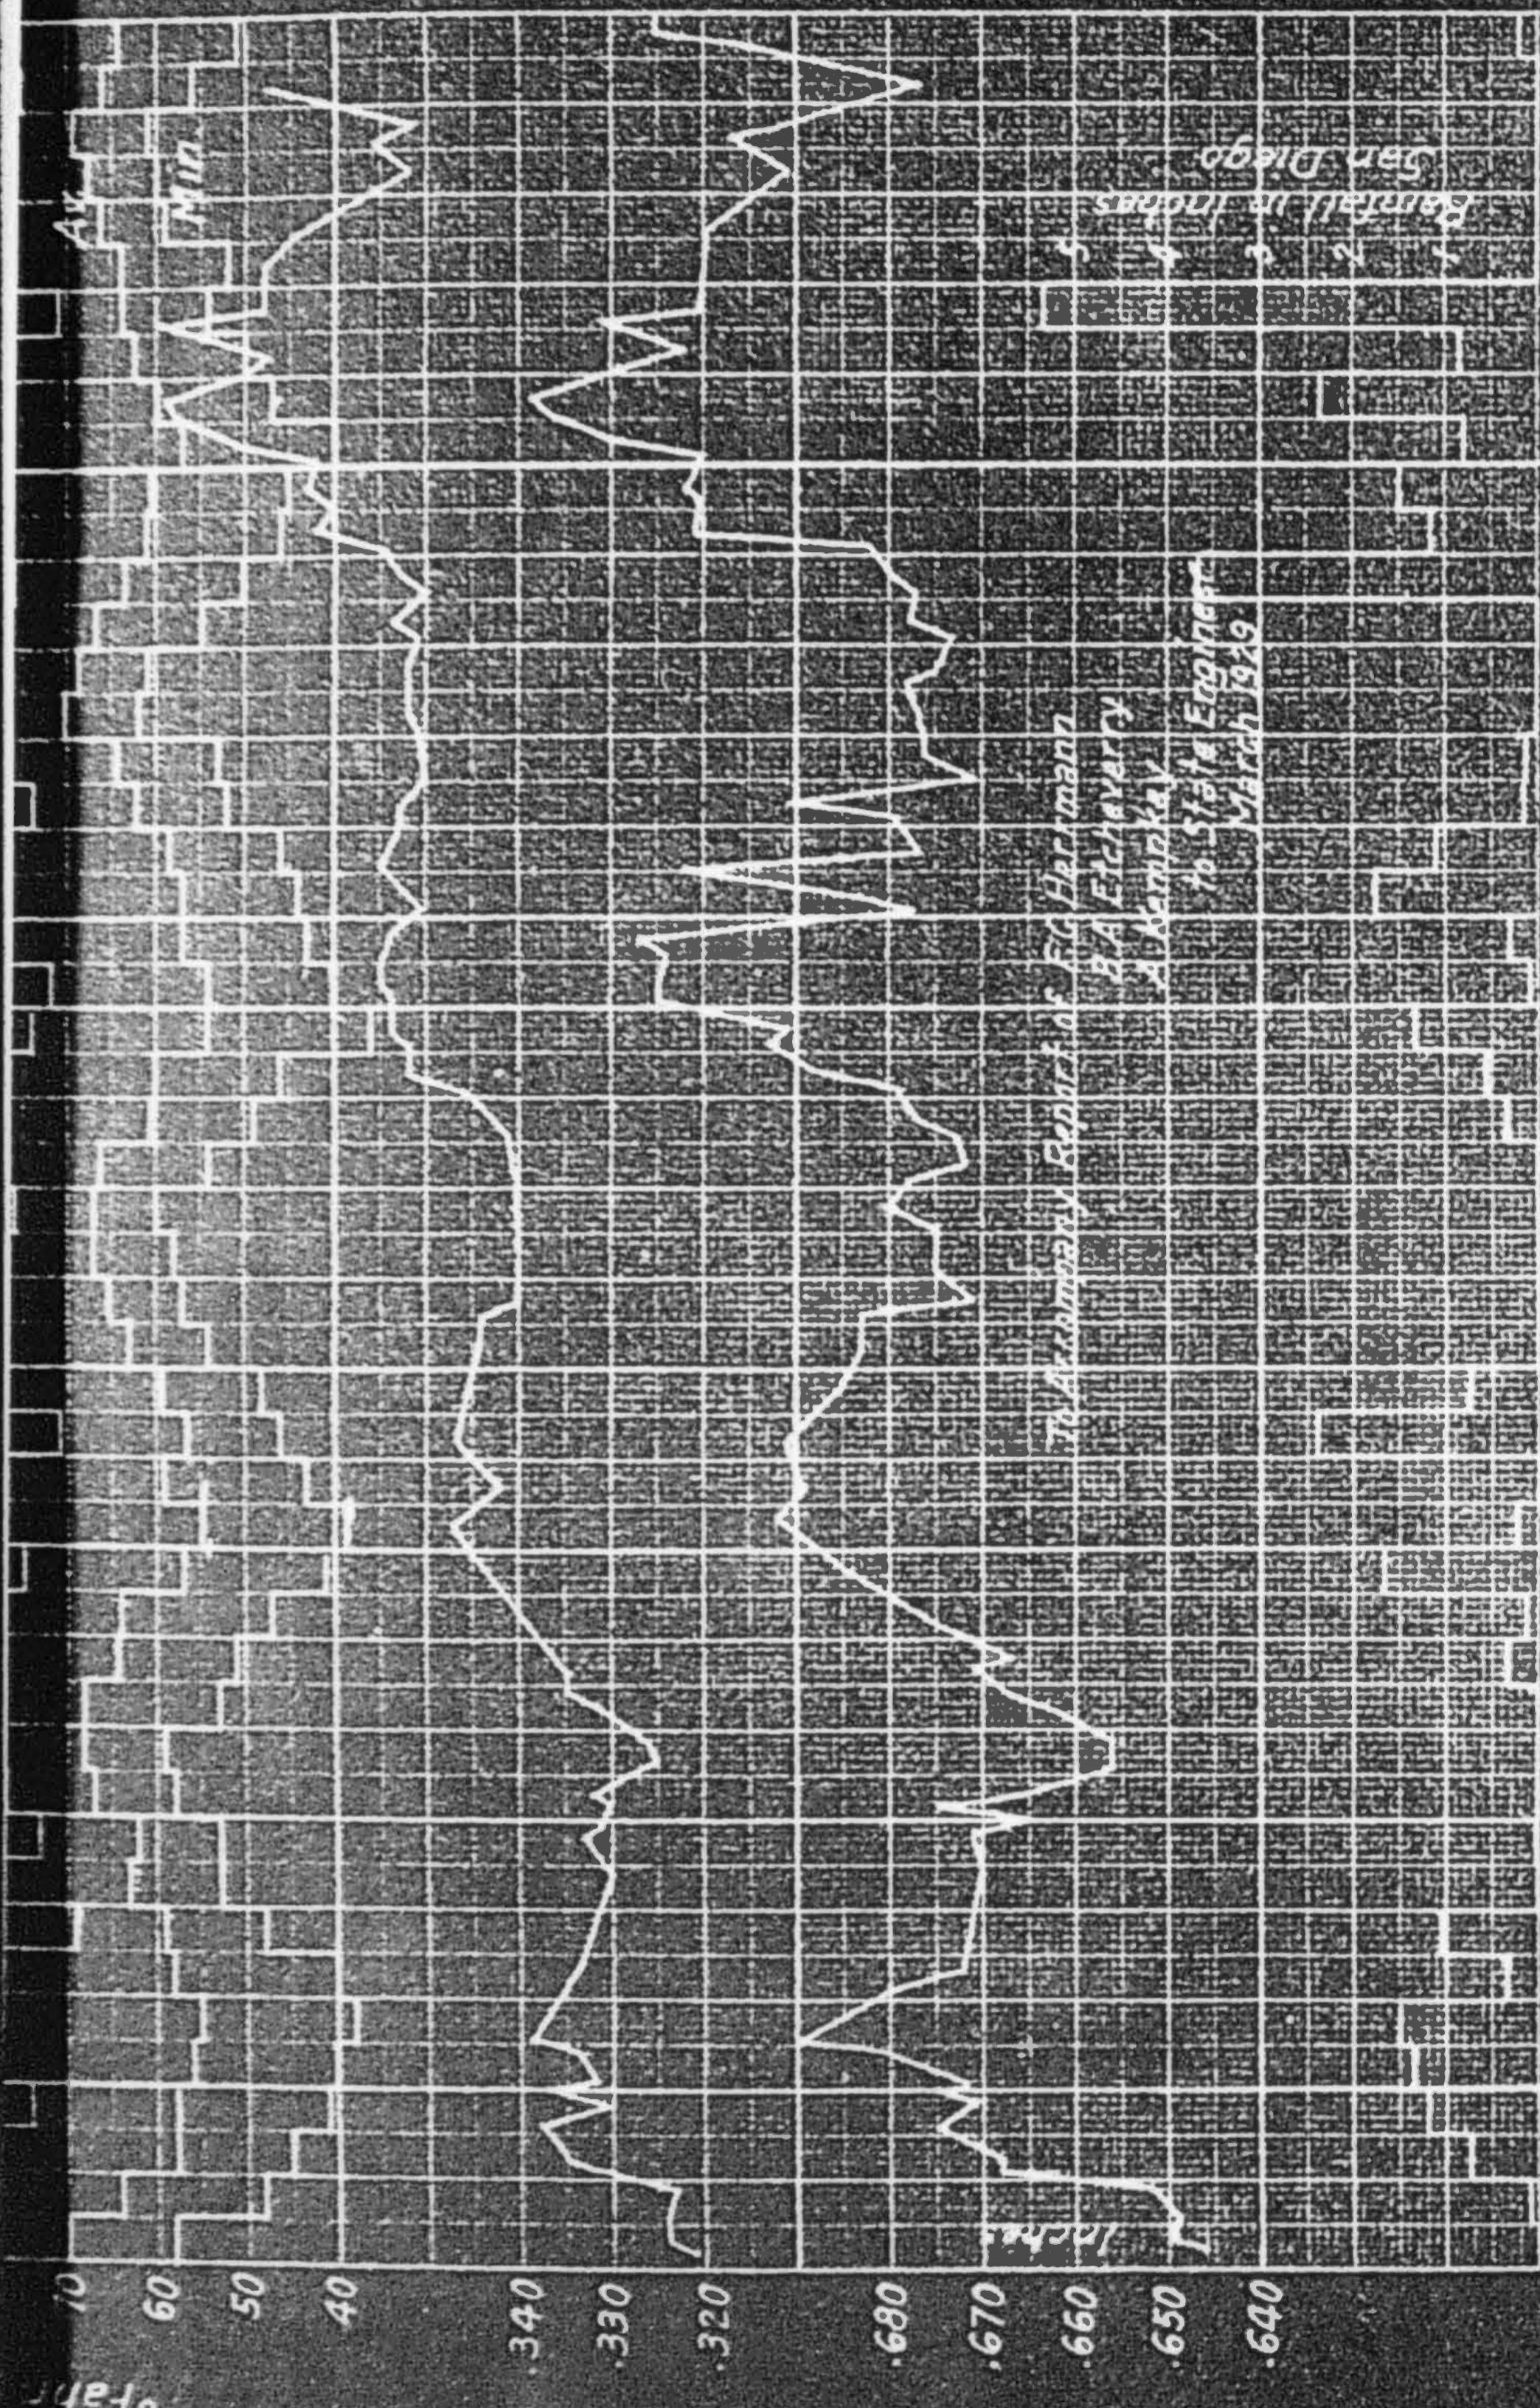
PLATE 3

We have plotted on separate graphs the micrometer measurements of the changes in the horizontal and vertical components of the width of the cracks, (Plates 3 to 7), and have studied the factors which might have a tendency to effect the changes, including the records of temperatures taken in the buttresses and the variations in water level in the reservoir.

J J A S O N D J F M A M J A S O
1925 1926
Lake Hodges Micrometeor Readings
Bu. of Fisheries No. 15 South Side.

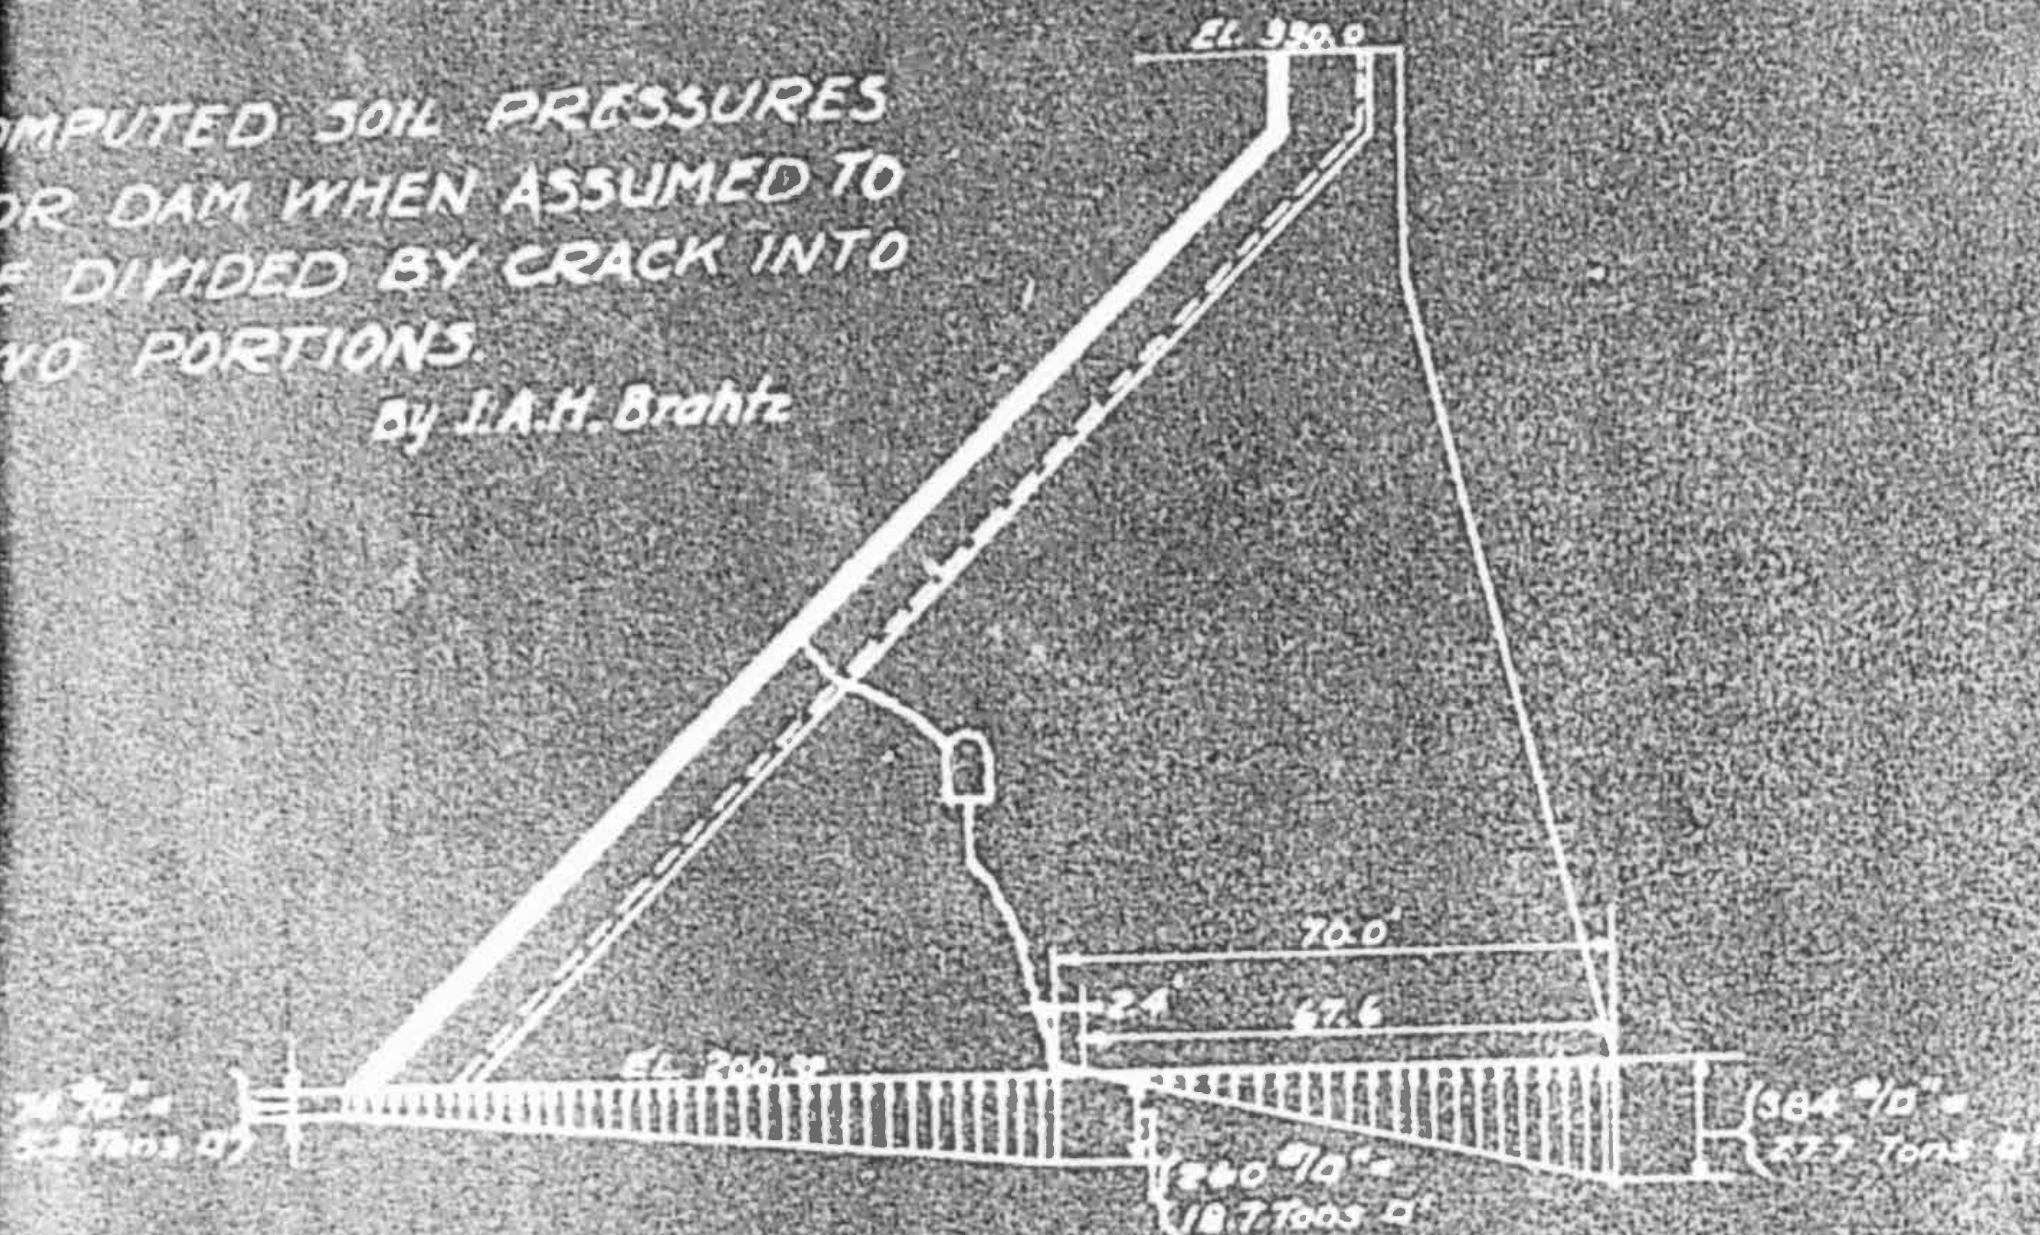
Fig. 2

Under the above assumption, i.e., that the dam is divided into two separate units by the cracks, Mr. Brahtz finds the following distribution of foundation pressure (See Fig. 2).

COMPUTED SOIL PRESSURES
FOR DAM WHEN ASSUMED TO
BE DIVIDED BY CRACK INTO
TWO PORTIONS.
