The George H. Scripps Memorial Marine Biological Laboratory
of the Scripps Institution of Oceanography
University of California, San Diego

Historic Structure Report to the California Office of Historic Preservation

SIO Reference 79-26

October 1979

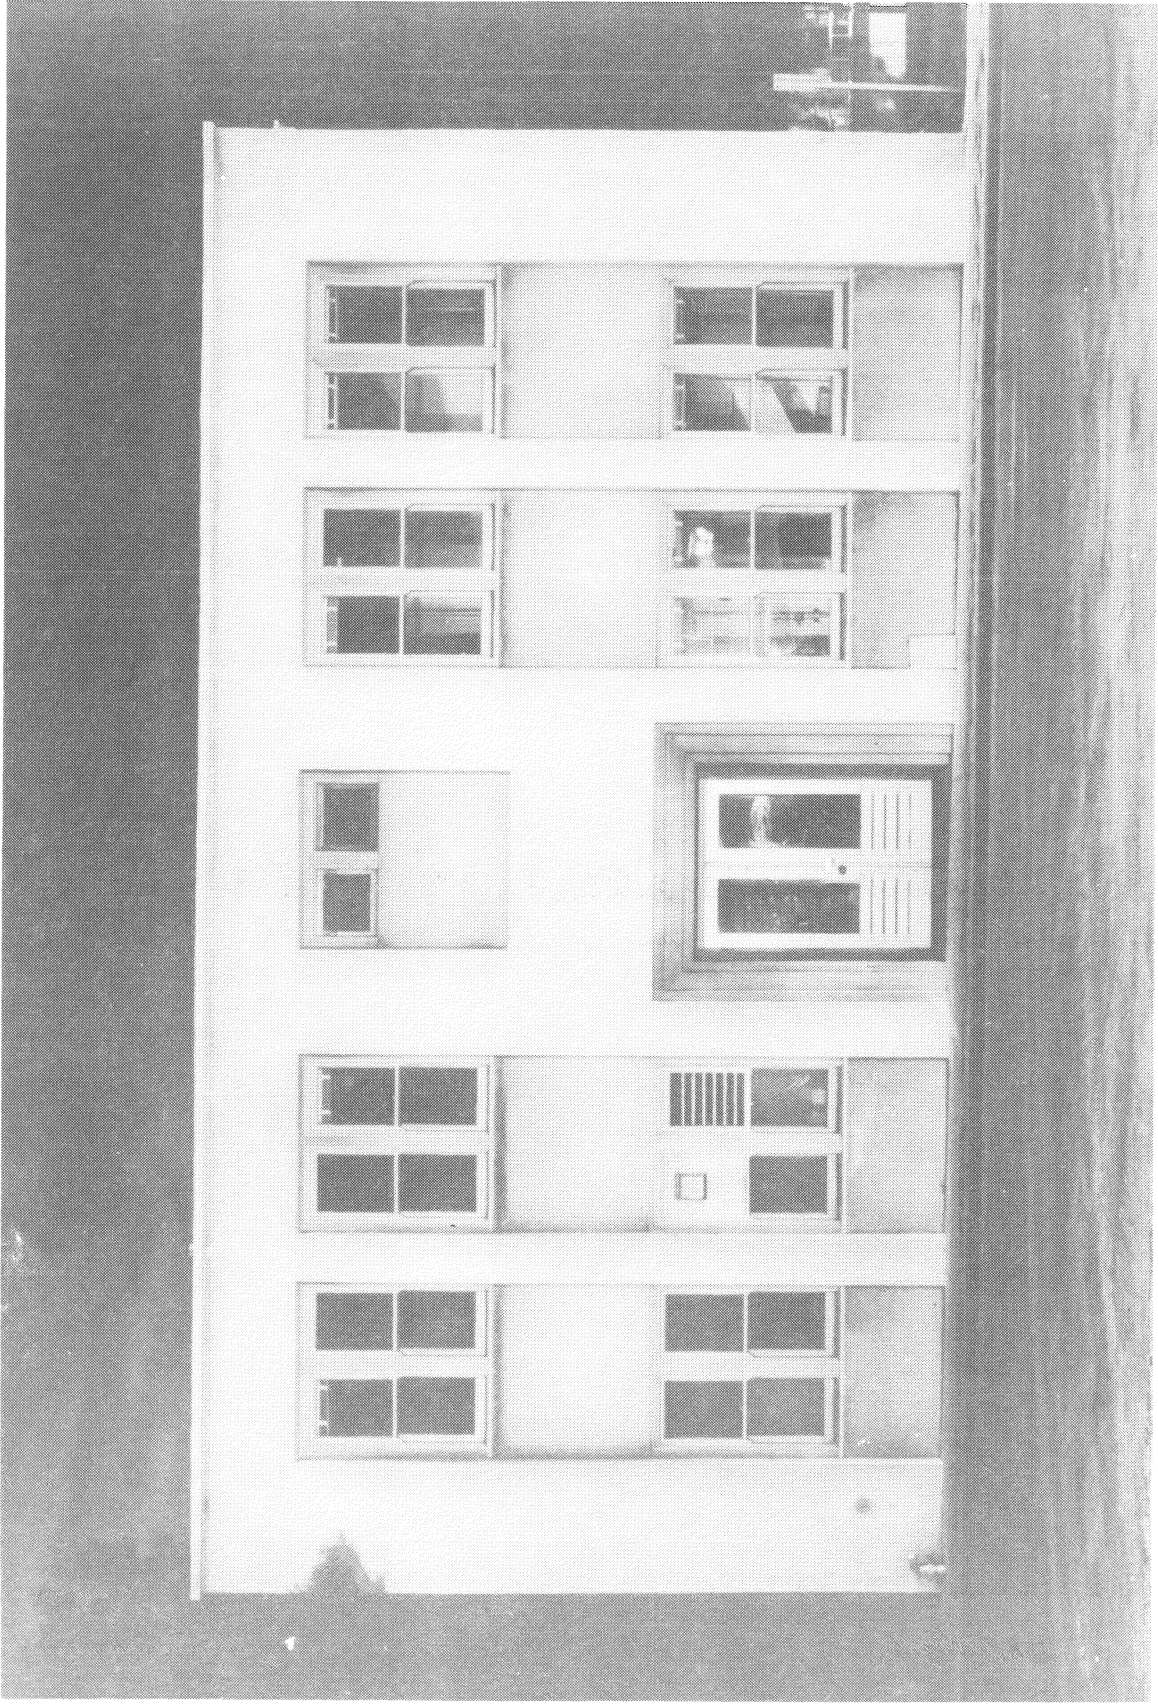
Figure 7. East view of Scripps Laboratory in 1977.

The exterior of Scripps Laboratory (figures 7-8) is much as it appeared after the 1932 remodelling, changed from its original appearance only by the change in window style. The dividers between lights of the original steel-frame windows tended to disappear from sight; in the wood-framed windows they are apparent. The windows are in pairs throughout the building (except at the southeast corner of the first floor on the south wall, where one is missing). Windows are of only two sizes: pairs of wide windows between columns on the north and south walls, and pairs of narrow windows on the east and west walls. Six window lights have been removed and replaced by air intakes and exhausts; two large vent pipes rise along the north wall. The exterior is painted uniformly with a buff paint, including all window frames, trim, and doors. Originally, at the completion of construction, it was plain concrete, with varnished woodwork on the doors.

The roof has four chimneys: the three that serve the laboratory offices on the north side, and a later addition at the center of the south side. The original chimney from the library room is gone. The skylights are still present, but the frames are badly corroded and may need replacement. The wire glass of the skylights is mixed; most is of the familiar hexagonal pattern; a few lights of the west skylight have a **diamond** pattern. Each skylight has a ventilator (passive) at its peak; they still operate. Two mechanical ventilator fans are mounted on the roof; one over the old classroom is rusted away, the other, which serves
